Problem: On 12/24/15, approximately 60 homes

within the Chanticleer Subdivision were without water and had no access to and from their homes when a 72-inch diameter corrugated metal pipe failed,

collapsing the road.

Propsed Solution: 1 - 72-inch RCP pipe with headwall

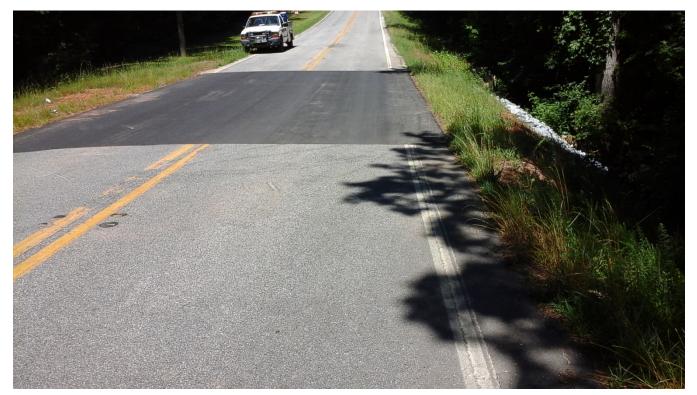
Photo 1: The large collapsed hole in Canterbury Lane was repaired and paved.

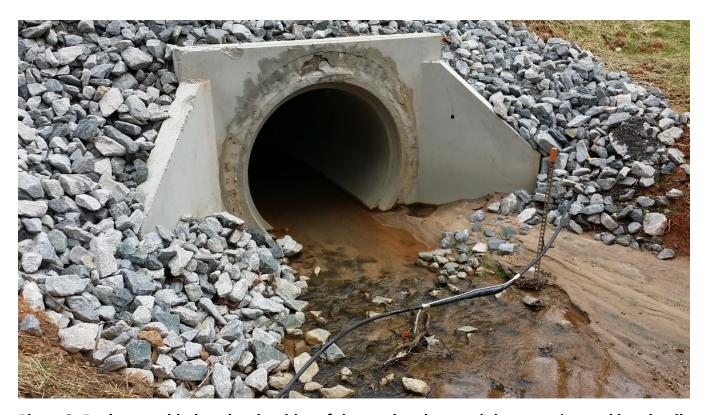
Photo 2: Rock was added to the shoulder of the road and around the new pipe and headwall.

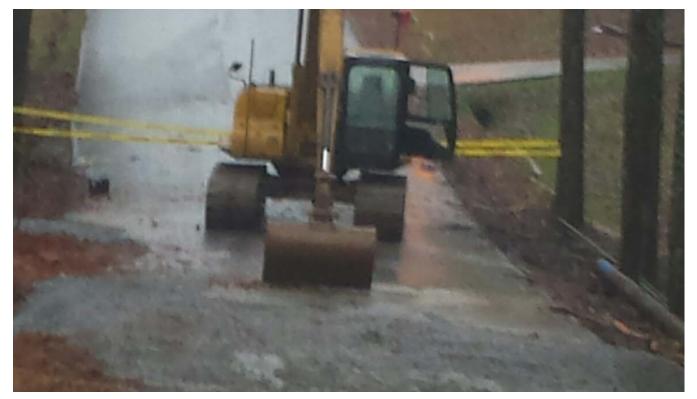
Photo 1: Canterbury Lane is being repaired for road reopening.

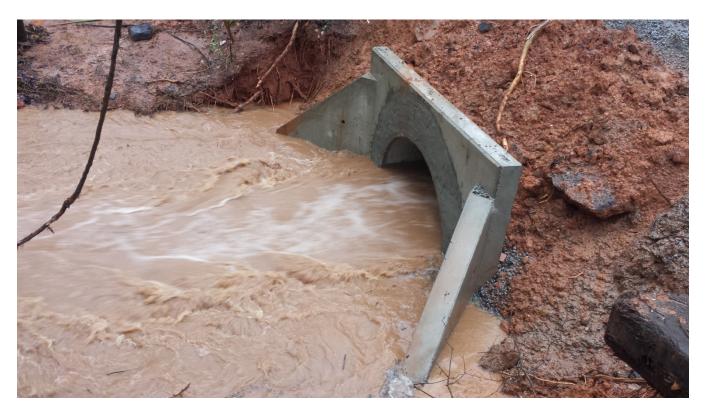
Photo 2: Photo shows water flowing through the new concrete pipe. Pipe replacement and new headwall installation was successful.

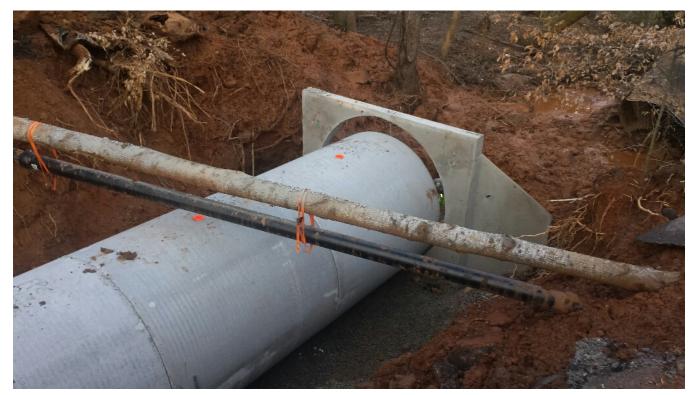
Photo 1: New 72" concrete pipe is being installed. Exposed utility lines are visible in the photo.

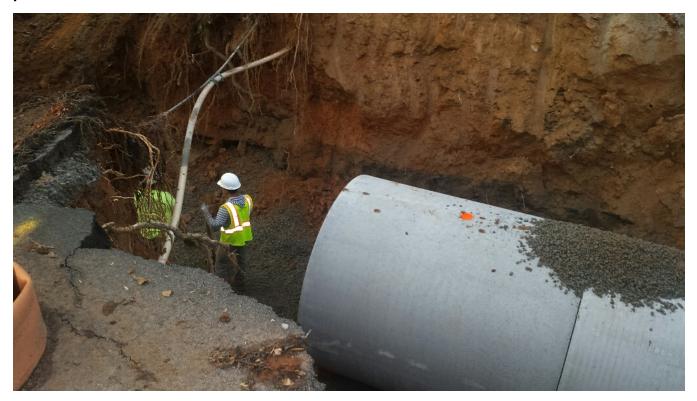
Photo 2: New 72" concrete pipe is being installed. Exposed utility lines are visible in the photo.

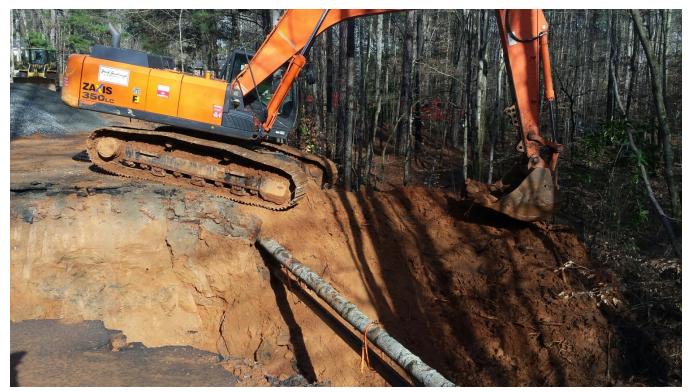
Photo 1: Site excavation and clean up underway to prepare for new pipe placement.

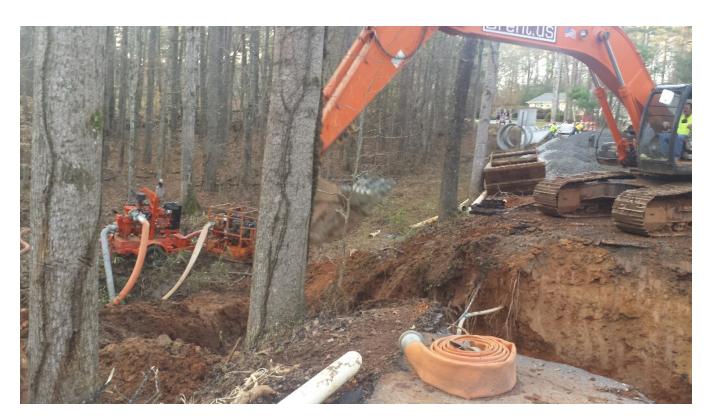
Photo 2: Site excavation, clean up and water pumping underway to prepare for new pipe placement.

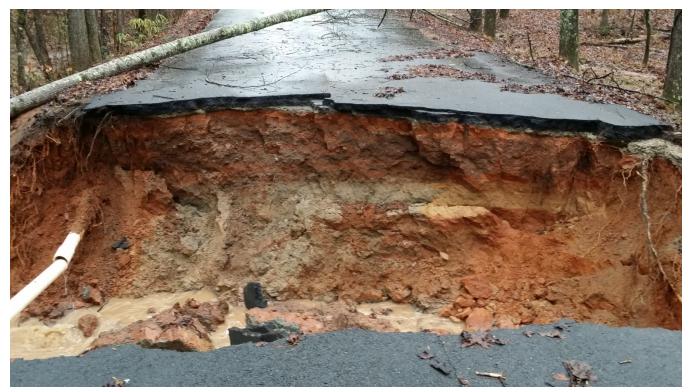
Photo 1: Approximately 60 homes within the Chanticleer Subdivision were without water and had no access to and from their homes when a 72-inch diameter metal pipe failed, collapsing the road.

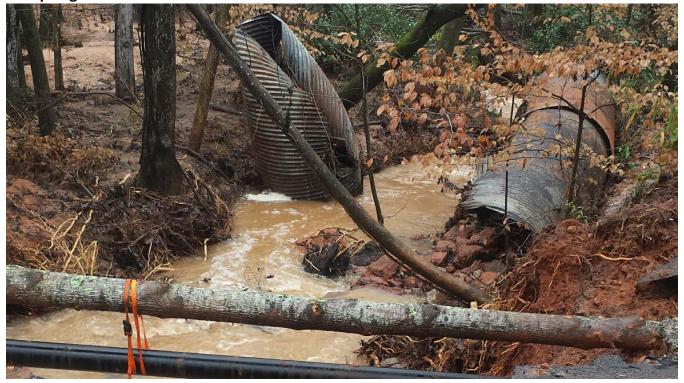
Photo 2: The metal pipes failed, washed out from under the road, and were found downstream from Canterbury Lane
